ECOROofs (GREENROofs) – A MORE SUSTAINABLE INFRASTRUCTURE

Tom Liptan¹ and Eric Strecker²

¹City of Portland, Bureau of Environmental Services, 1120 SW 5th Ave., Portland, Oregon 97204 Ph.503 823 7267 TomL@BES.ci.portland.or.us

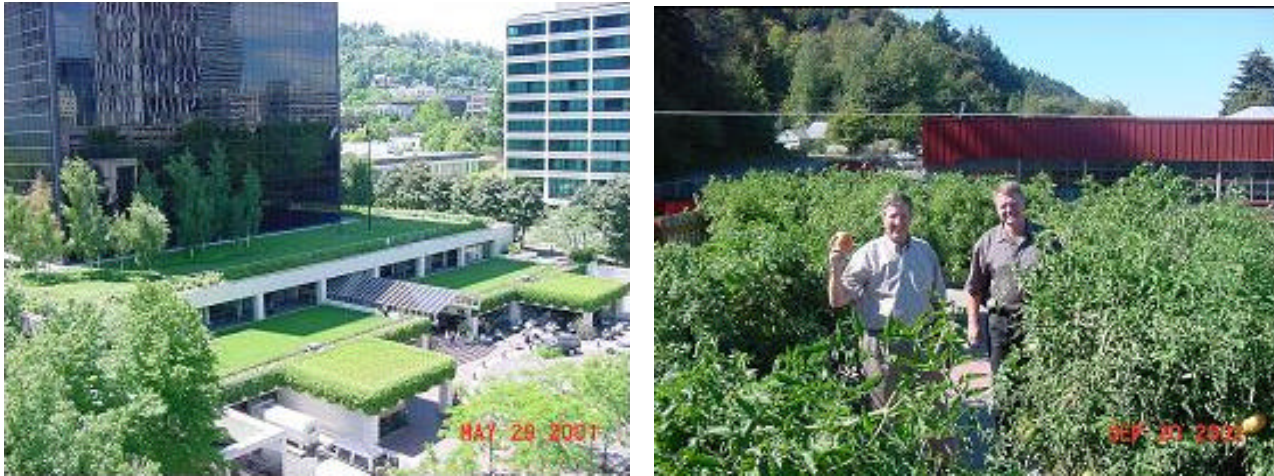
Figure 2. An aerial view of a typical Roof Garden in downtown Portland and Doug Christie and Cameron Hyde atop Doug's ag-roof in Portland with crops shown.

A traditional Roof Garden (see example in Figure 2, left photo) by comparison usually requires more substantial structural building upgrade and is made up of heavy soils and vegetation, often including trees, and requires significantly more irrigation and maintenance. Roof gardens may cover only a small percentage of the roof surface and usually have paved terraces for people to use. Although they do provide some benefits not found with the use of conventional roofs, they do not provide the benefits as an EcoRoof. They also are generally much more expensive to build and maintain than conventional roofs. EcoRoofs are more comparable in cost to standard roofs.

Another type of vegetated roof is an ag-roof (see example in Figure 2, right photo). Some building owners are finding it advantageous to grow crops on their rooftops. One such Portlander harvests hundreds of pounds of tomatoes each week.

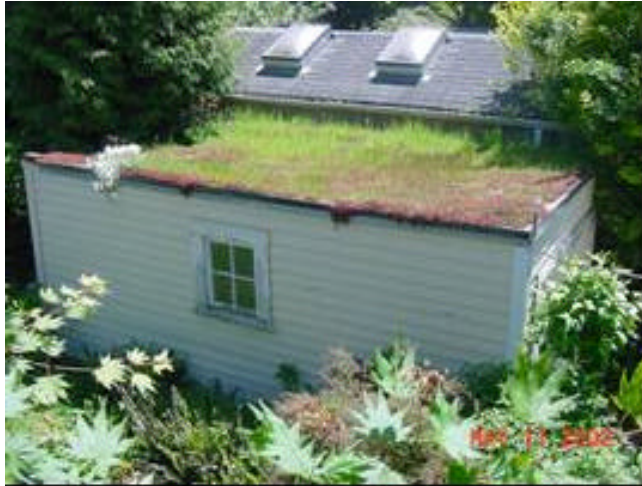
Figure 3. View of a residential garage EcoRoof that was monitored for a two-year period.

An EcoRoof was installed on a structure shown (Figure 3) in October 1996 . The building structure was upgraded and a waterproof membrane was applied over the existing composite rollout shingles. Two to three inches of topsoil and compost mix were applied and planted with seven species of sedum. Grass has also grown on its own with what appears to be four predominate species. The EcoRoof is 180 ft² and has about a 7% slope toward the east. About half of the roof has full solar exposure and the other half is partially shaded. Figure 3 shows the EcoRoof in late spring 2002.

BES monitored rainfall retention of the garage EcoRoof from August of 1997 until October of 1999. A rain gage was installed on the EcoRoof and the roof downspout was connected to two tanks with a total capacity of 78 gallons. A spreadsheet was created to record the rainfall, runoff and retention. The rain gage and tanks were checked every morning and evening during storm events. Any flow in the tanks represented runoff and the difference between rainfall and runoff was the retention. Figure 4 shows the precipitation retention for the 27-month period. Figure 5 show the results of a rainfall simulation test to identify how peak flows might be attenuated. In the test, a large volume of water was applied to the roof and then the recorded runoff was compared to this volume. Water was applied with a garden hose and before each application the flow from the hose was measured and recorded.

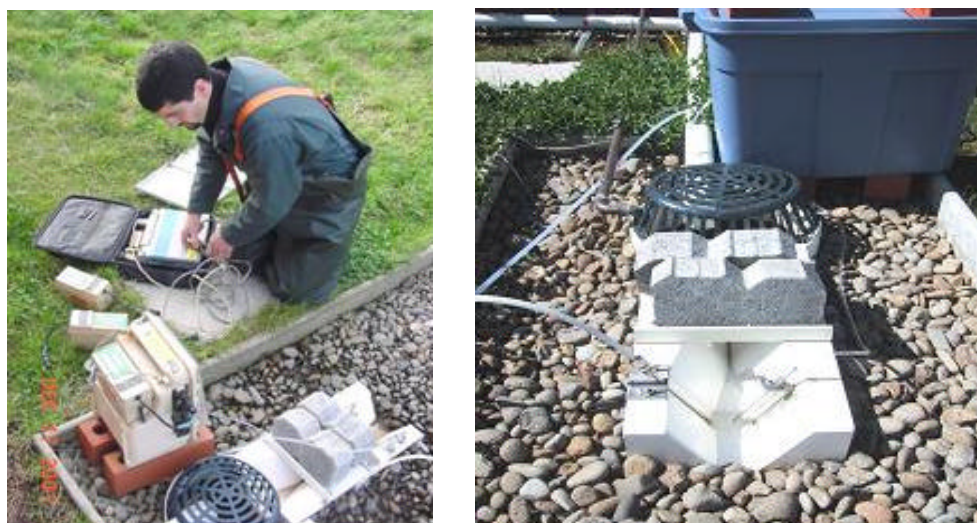
Figure 8 . Two photographs of one of the monitoring stations. One shows the data logger and bubbler with the flume and the second is a close-up of the flume.

Flow monitoring equipment includes a small 60-degree, V-trapezoidal Plasti-Fab flume, and a hydraulic bubbler-type flow meter, which measures the water level in the flume as shown in Figure 8 . The flumes were custom made to attach to the two main drainage points. This data is instantaneously transmitted to the BES Lab where it is converted and stored on the BES computer network.

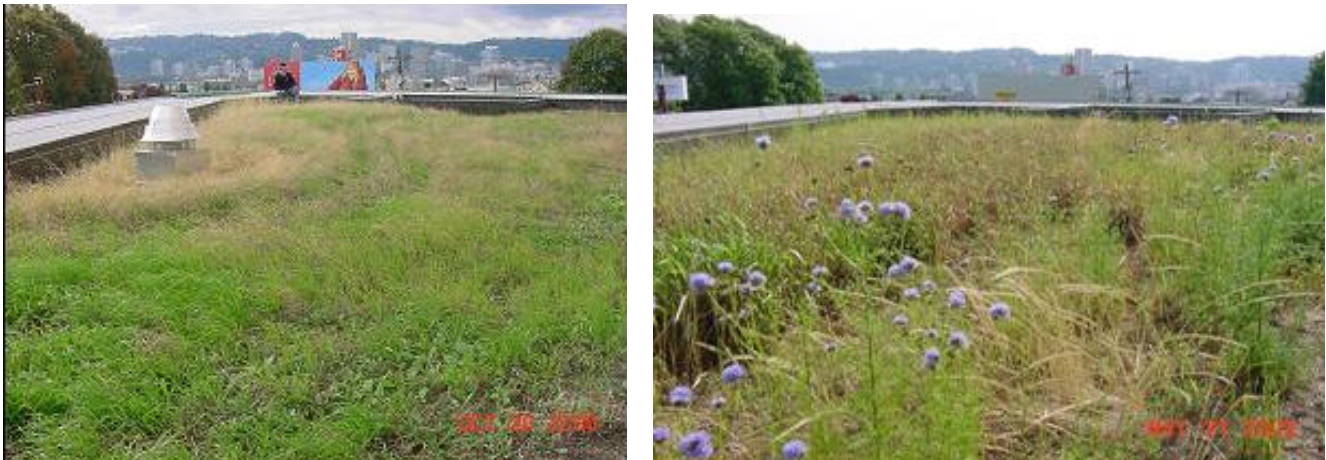
Figure 14. Two photographs of the Buckman Terrace EcoRoof showing uses of grasses and wildflowers.

The entire building has a roof area of approximately 25,000 ft² and is constructed with sufficient structural capacity to hold an EcoRoof. As a test, EcoRoofs were placed on two sections. Figure 14 shows the main EcoRoof, which comprises over 1,500 ft² of commercial space that has full solar exposure. An additional 750 ft² of impervious roof area drains onto this south facing EcoRoof. Figure 15 shows the entrance EcoRoof, which is also planted with sword fern, licorice fern and white stonecrop. It is on the eastside and is in the shade of a north-facing wall. Both were planted in March 2000. The main EcoRoof was planted with two species of Oregon sedum, various wildflowers, native grasses and a few licorice ferns. Grasses and wildflowers were planted from seed and mulch was hand broadcast to protect against wind erosion. An irrigation system has not been installed for either EcoRoof. The soil profile is 4 in. deep and 20 lbs ft² when saturated. American Hydrotech waterproof membrane and reservoir drain system was used. BES staff specified the soil mix and vegetation.

While the grasses and wildflowers achieved a graceful, flowing appearance, they are reminiscent of an Eastern Oregon or Midwestern American prairie. Since residents who would rather have a “greener look,”
